Single Survey

Property address	39 Eastfield Road Dumfries DG1 2EJ
Customer	Mr & Mrs Carmichael
Customer address	39 Eastfield Road Dumfries DG1 2EJ
Prepared by	Shepherd Chartered Surveyors
Date of inspection	01/05/2026

Survey Report

Property Surveyed: 39 Eastfield Road, Dumfries, DG1 2EJ

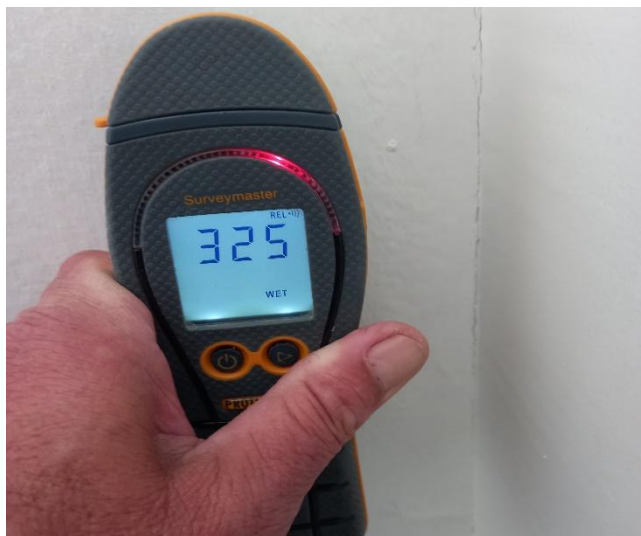
Room Front left bedroom

Elevated moisture levels were recorded in this room to the front left corner with some slight disruption to the wallpaper, externally there are some slight defects to the wall pointing possibly allowing rainwater ingress. This area should be repointed as required and the wall monitored to ensure drying out occurs on completion of the repointing.

Elevated moisture levels in corner of front bedroom

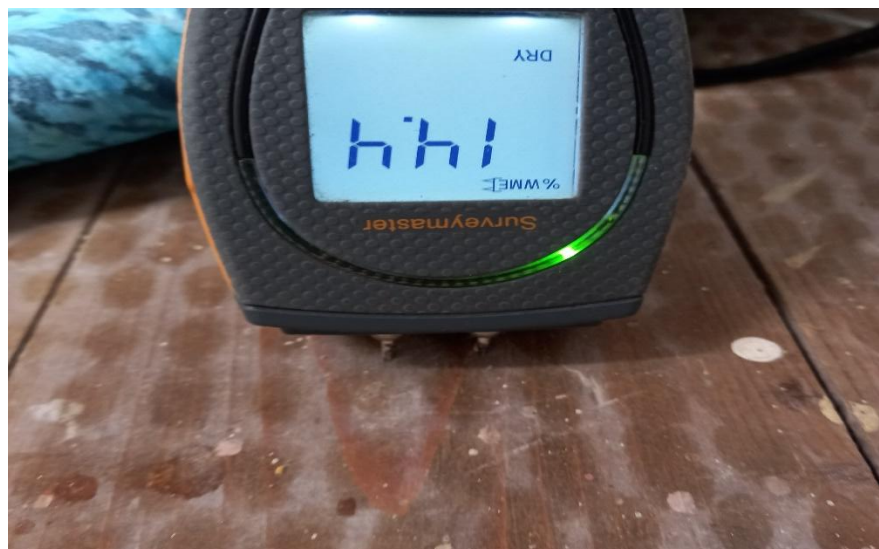
The carpet in the front bedroom was turned back in the front corner and no excessive moisture levels were recorded from the top surface of the floorboards therefore no recommendations are made.

Normal moisture of 14.4% in front bedroom floor

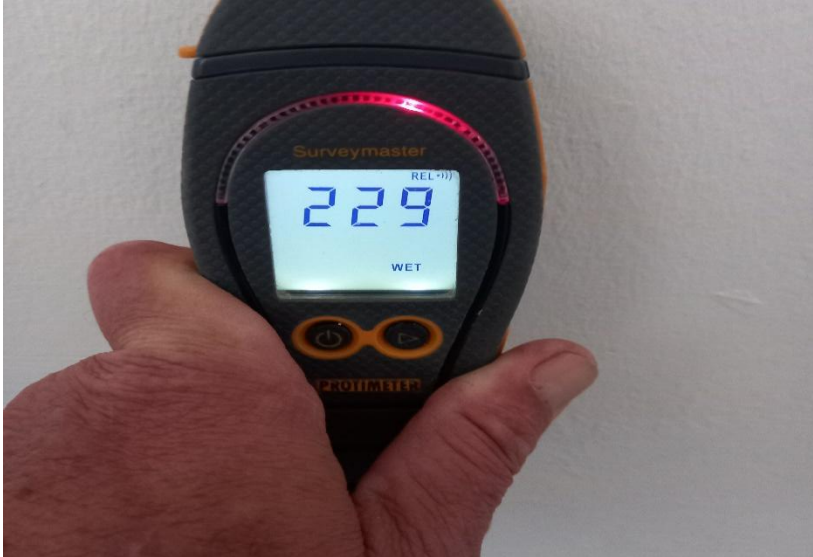
Rear Bedroom

The internal wall between the bedroom and bathroom was tested and elevated moisture levels were recorded on a section of this wall on the opposite side of the bath. The remaining section of wall was dry this would indicate the damp and elevated moisture levels are due to defective seals around the bath allowing water to penetrate the wall. We would recommend the bath be re-sealed and on completion the wall should be monitored to ensure drying out occurs

Elevated moisture levels on bedroom wall opposite the bath

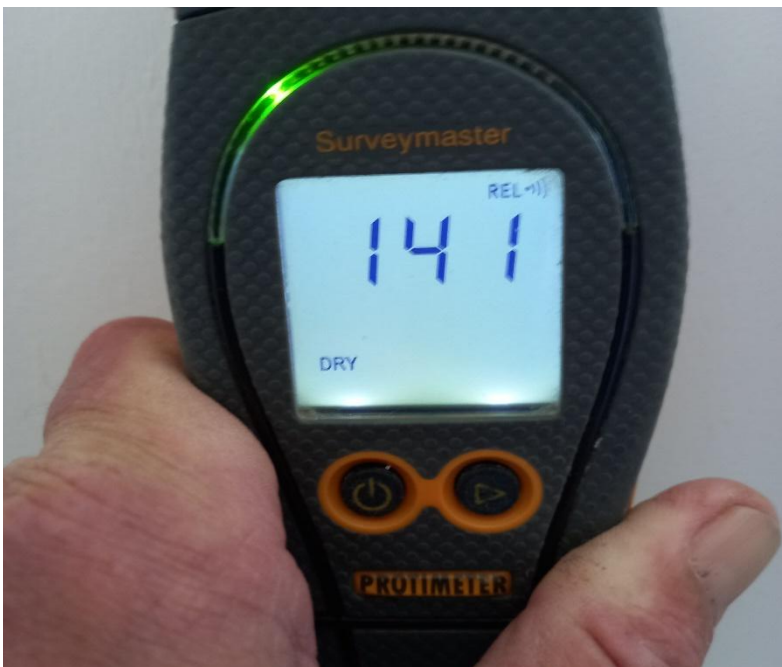
Rising Damp

Using instrumental analysis, we were unable to record any readings which would suggest a presence of rising damp where the walls was tested at various points throughout the property therefore no further rising damp treatments are recommended.

Low average moisture levels from walls tested in property
