Home Report

Scottish Single Survey

Property address	7 Hardthorn Road Dumfries DG2 9JG
-------------------------	---

Prepared by	Shepherd Chartered Surveyors
--------------------	------------------------------

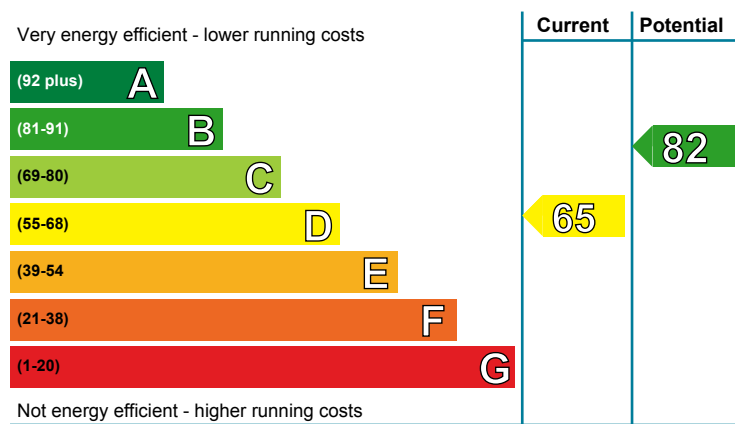
Energy Efficiency Rating

This graph shows the current efficiency of your home, taking into account both energy efficiency and fuel costs. The higher this rating, the lower your fuel bills are likely to be.

Your current rating is **band D (65)**. The average rating for EPCs in Scotland is **band D (61)**.

The potential rating shows the effect of undertaking all of the improvement measures listed within your recommendations report.

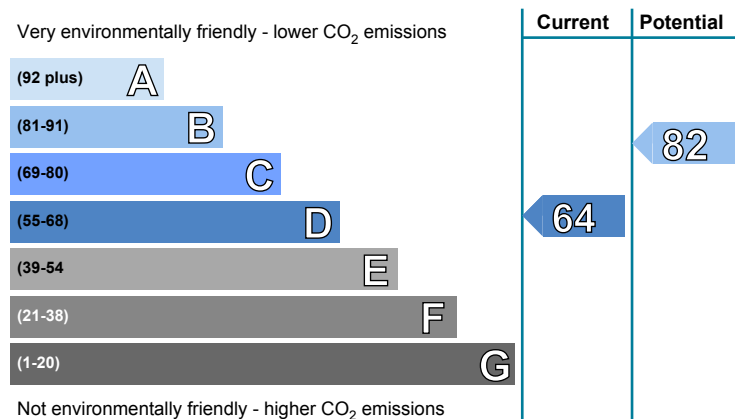
Environmental Impact (CO₂) Rating

This graph shows the effect of your home on the environment in terms of carbon dioxide (CO₂) emissions. The higher the rating, the less impact it has on the environment.
