HOME REPORT

41 COLLEGE ROAD
DUMFRIES
DG2 0QL

Single Survey

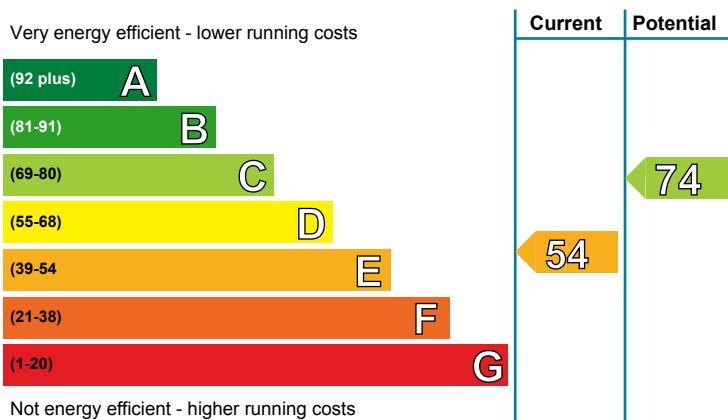
Energy Efficiency Rating

This graph shows the current efficiency of your home, taking into account both energy efficiency and fuel costs. The higher this rating, the lower your fuel bills are likely to be.

Your current rating is **band E (54)**. The average rating for EPCs in Scotland is **band D (61)**.

The potential rating shows the effect of undertaking all of the improvement measures listed within your recommendations report.

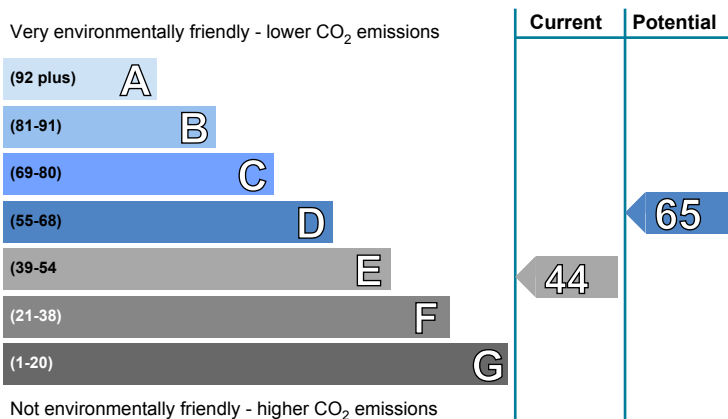
Environmental Impact (CO₂) Rating

This graph shows the effect of your home on the environment in terms of carbon dioxide (CO₂) emissions. The higher the rating, the less impact it has on the environment.

Your current rating is **band E (44)**. The average rating for EPCs in Scotland is **band D (59)**.

The potential rating shows the effect of undertaking all of the improvement measures listed within your recommendations report.
