YOUR ONESURVEY
HOME REPORT

5 Nursery Place
Annan
DG12 5DD

SINGLE SURVEY

Single Survey

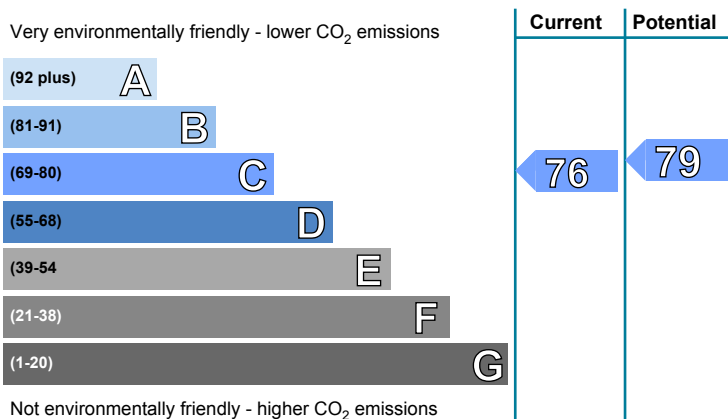
Environmental Impact (CO₂) Rating

This graph shows the effect of your home on the environment in terms of carbon dioxide (CO₂) emissions. The higher the rating, the less impact it has on the environment.
