# YOUR ONESURVEY HOME REPORT

4 Memory Lane  
Gatehouse Of Fleet  
Castle Douglas  
DG7 2JF

# Single Survey

# Mortgage Valuation Report

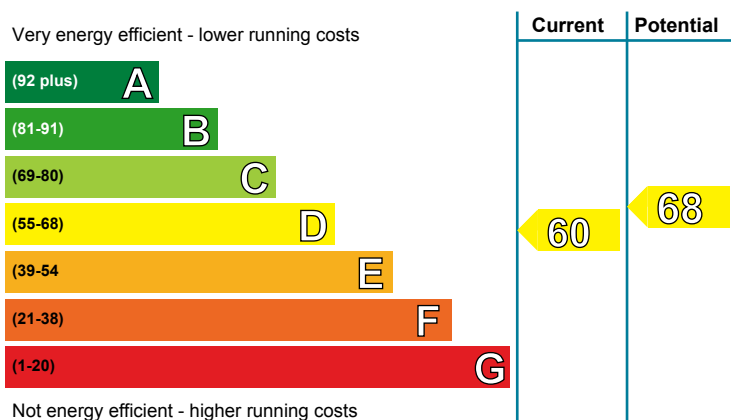
## Energy Efficiency Rating

This graph shows the current efficiency of your home, taking into account both energy efficiency and fuel costs. The higher this rating, the lower your fuel bills are likely to be.

The potential rating shows the effect of undertaking all of the improvement measures listed within your recommendations report.

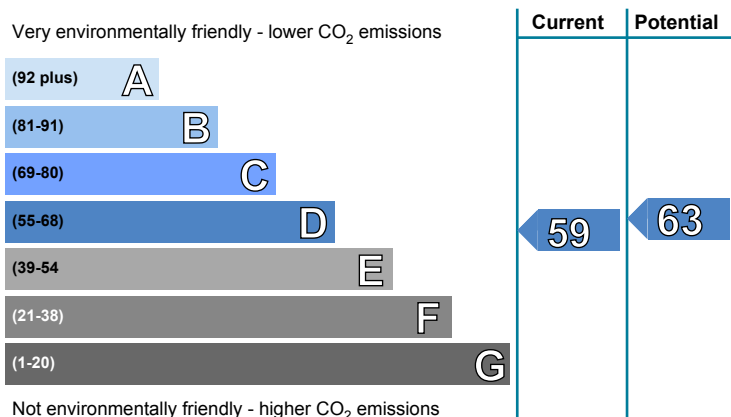
## Environmental Impact (CO<sub>2</sub>) Rating

This graph shows the effect of your home on the environment in terms of carbon dioxide (CO<sub>2</sub>) emissions. The higher the rating, the less impact it has on the environment.
